**APPENDIX Y**  
**Biophysical Survey (R2)**

**Re: Fibreco Terminal Enhancement Project, North Vancouver Biophysical Survey –  
Terrestrial Habitat Assessment**

Hemmera Envirochem Inc. (“Hemmera”) was retained by Fibreco Export Inc. (Fibreco) to conduct a General Biophysical Assessment for the Wood Products Terminal Facility Lease Property (the “Site”) located east of the Lions Gate Bridge, in the District of North Vancouver, BC. The Site is located along the north shore of Burrard Inlet’s Inner Harbour near the First Narrows. The Site extends approximately 150 m in length along the foreshore and is approximately 300 m at its widest point. This assessment is intended to describe intertidal and subtidal biophysical conditions, habitat values and potential fish and wildlife species use.

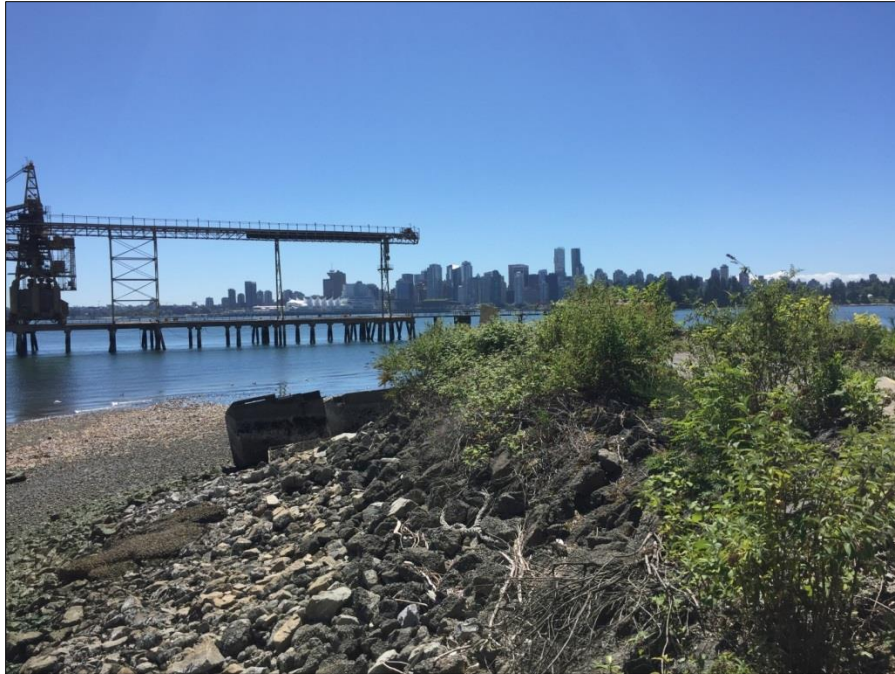
**Photo 1** Rip-rap and vegetation looking south at Project site rail jetty modification area, east side

Substrates are predominately imported fill, with rip-rap banks adjacent to the foreshore, with no native soils present. Vegetation is restricted to pockets within the rip-rap and isolated patches along the edges of the Project site (**Photos 1 to 3**). No natural ecosystems exist within the Project footprint.

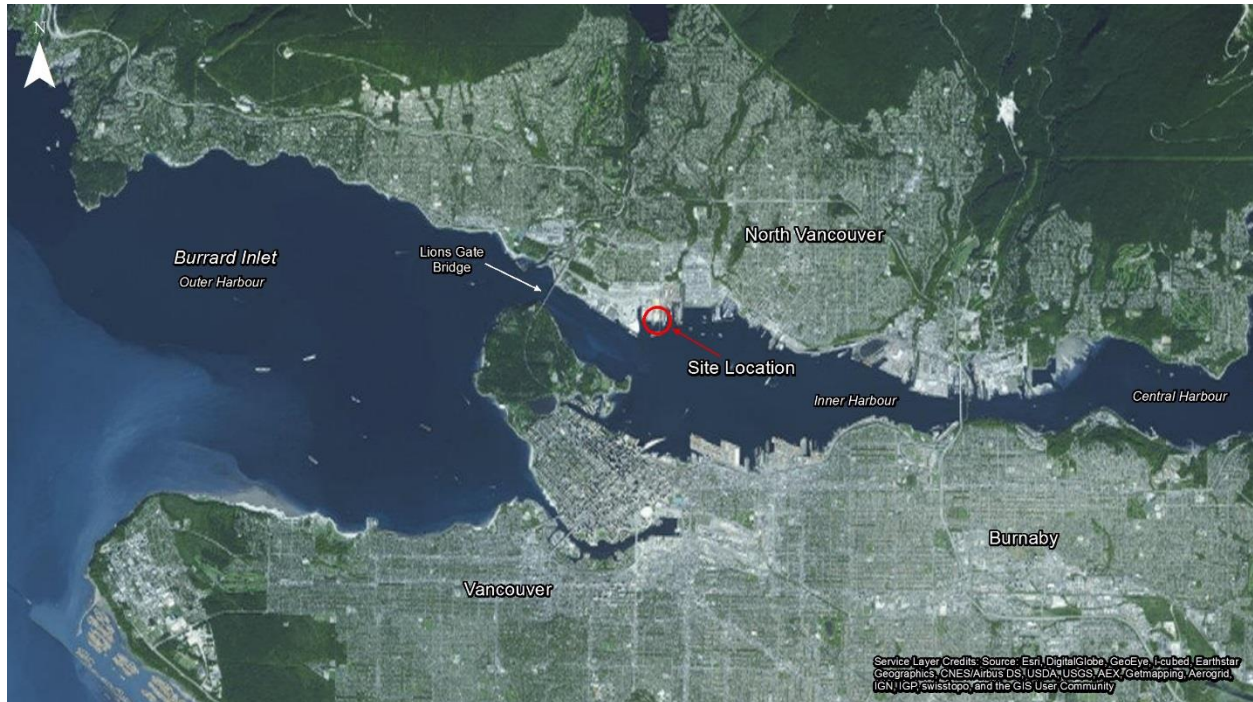
**Figure 1 Fibreco Project Site – Regional Setting**

Fibreco’s woodchip loading facility is located at 1209 McKen Avenue in the City of North Vancouver, BC (**Figure 1**). The proposed project site (the Site) is located along the north shore of Burrard Inlet, in Vancouver’s Inner Harbour, west of the Lions Gate Bridge and First Narrows (**Figure 1, Figure 2**) and adjacent to the Seaspan’s Burrard Drydock (to the east) and Lafarge (to the west). Coordinates for the centre of the survey area are: 492020 E 5461863 N.

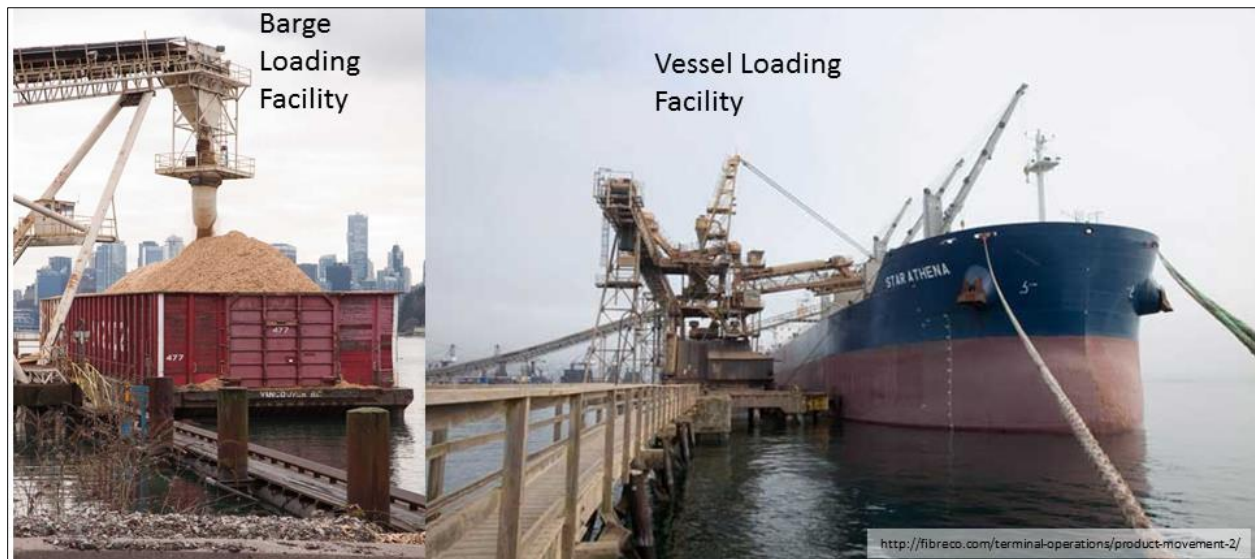
**Photo 1 Barge Loading Facility and Vessel Loading Facility**

The Site features a pile-supported transfer conveyor system extending approximately 200 m offshore to the ship berth structure. The ship berth structure is composed of a series of pile supported dolphins with a moveable ship loader, which extends approximately 270 m parallel to shore. A second loading facility composed of a dock and conveyor barge loader extending approximately 100 m parallel to the shore on the west side of the property and adjacent to an existing rail jetty.

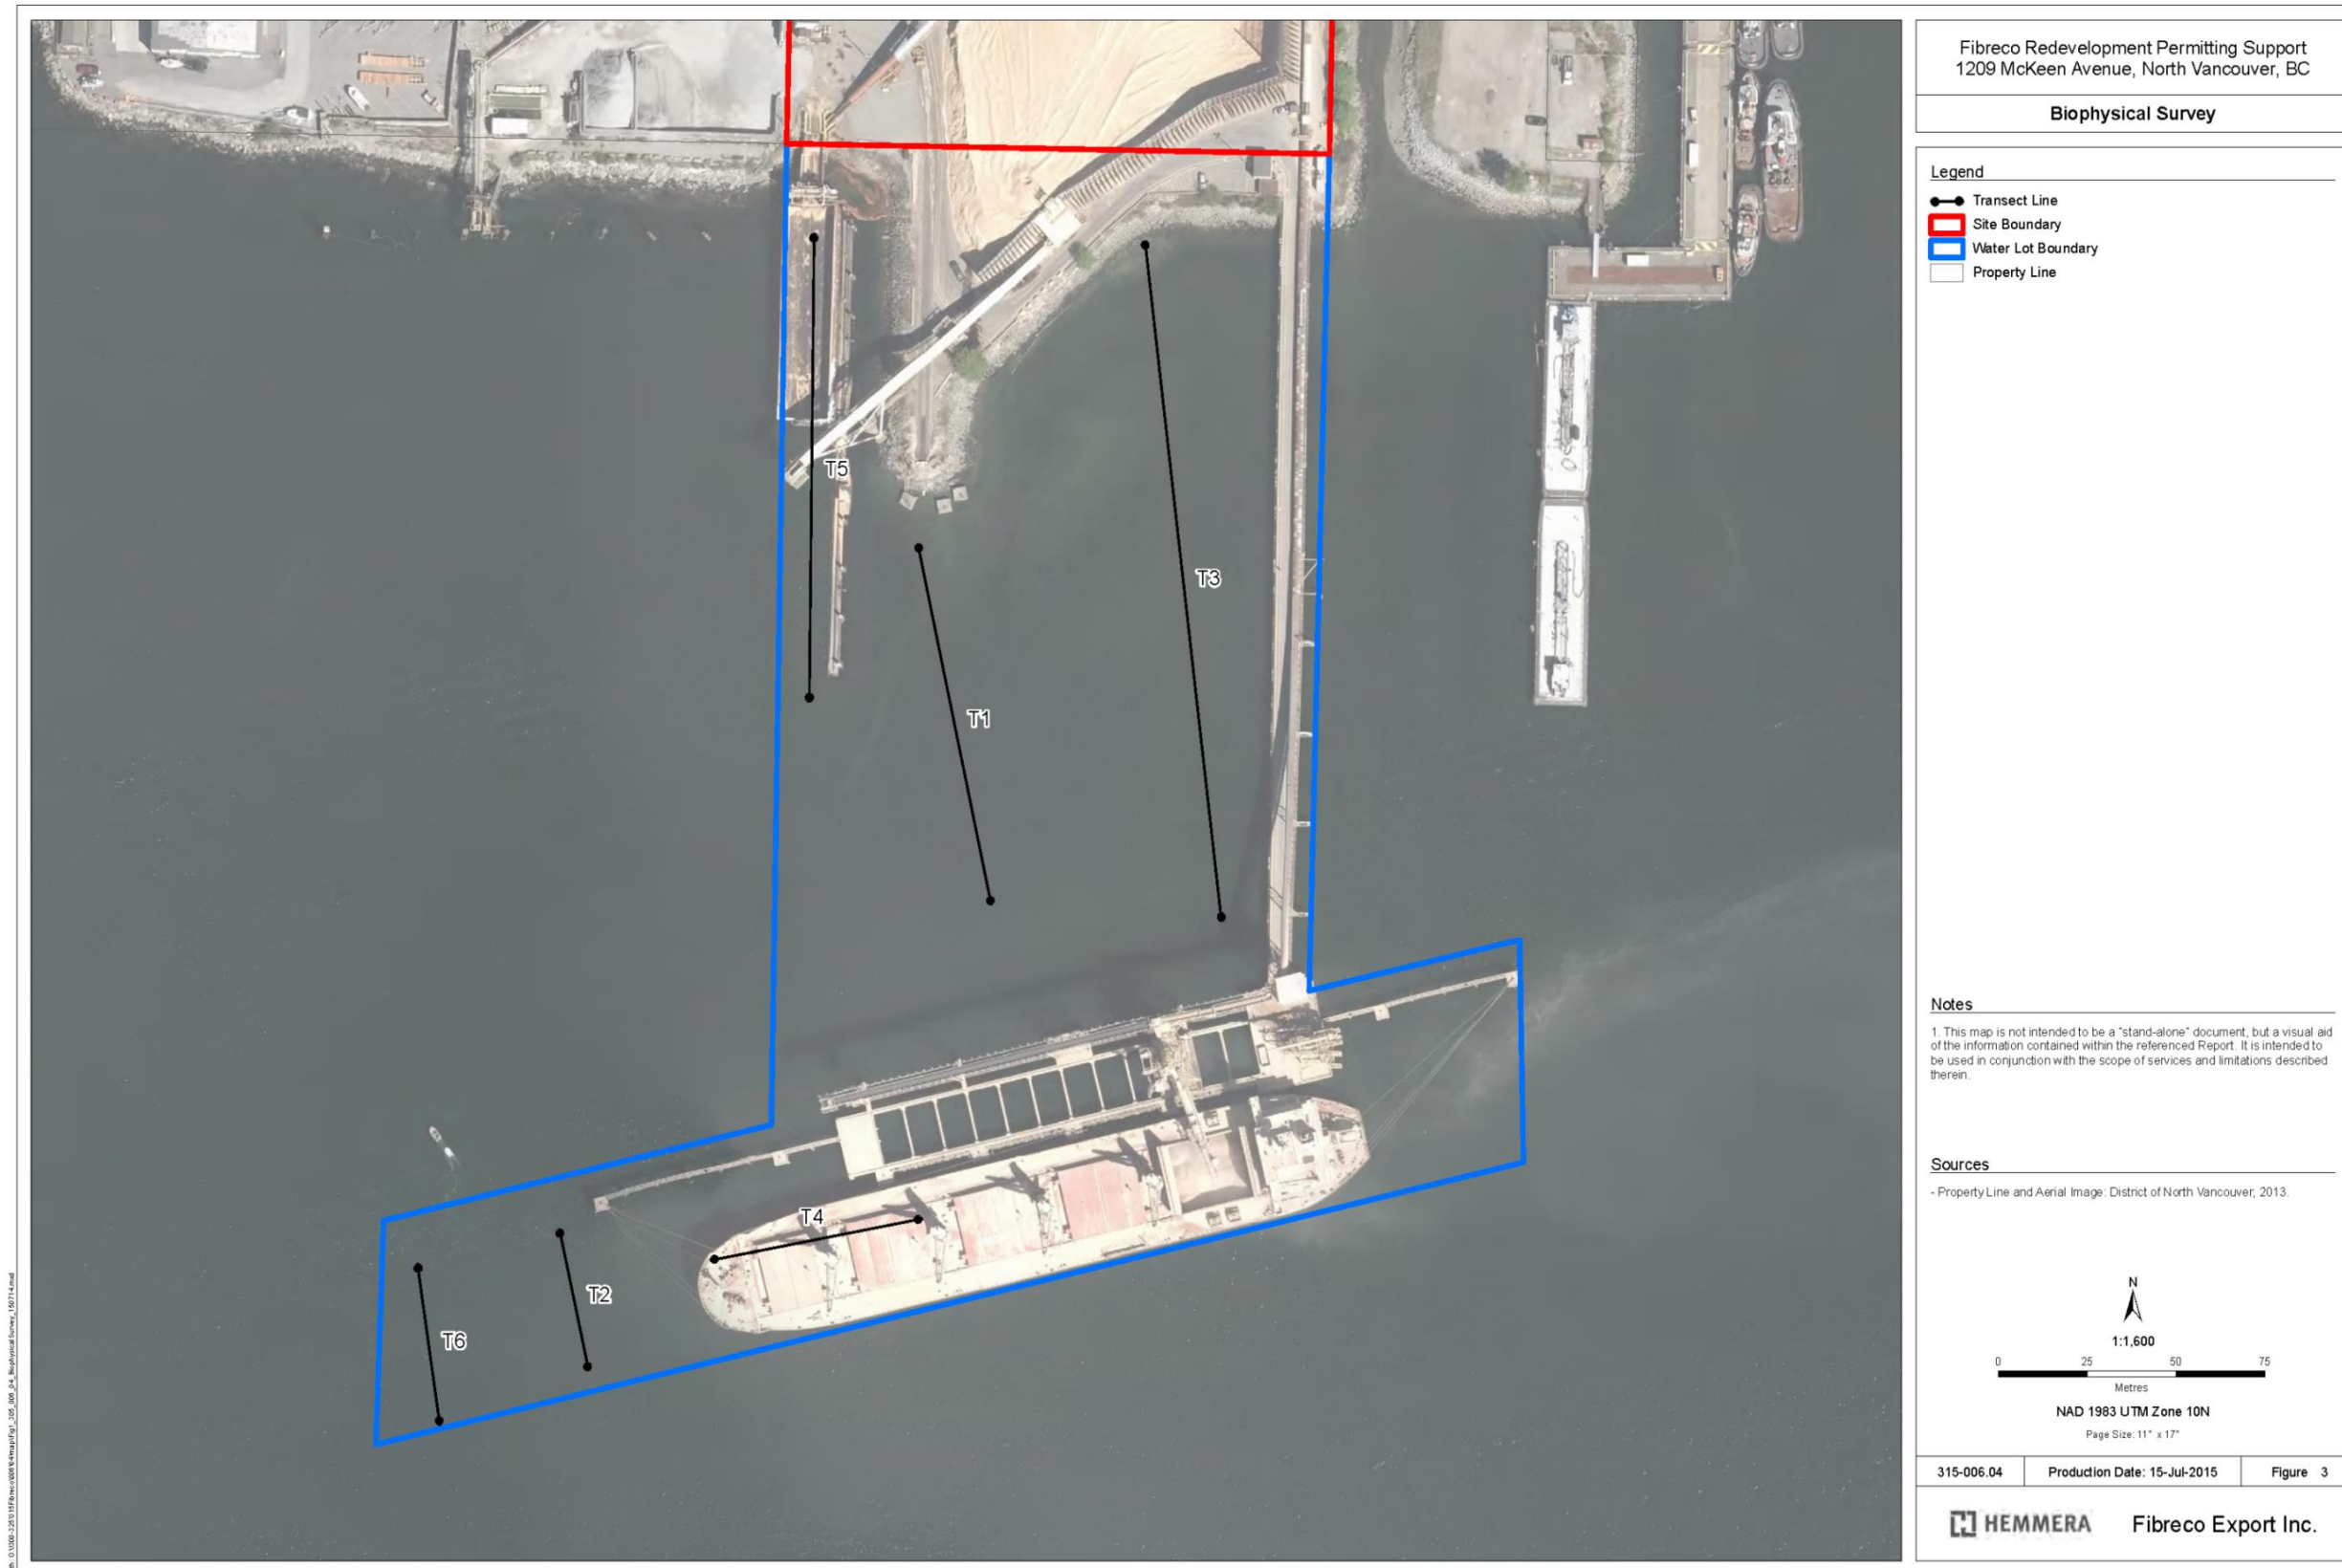
Figure 3 Biophysical Transect Locations at the Fibreco Site

A subtidal biophysical assessment was conducted at the Site on June 9<sup>th</sup> and 10<sup>th</sup>, 2015. The survey design was based on criteria outlined in *Standard methods for sampling resources and habitats in coastal subtidal regions of British Columbia* (Robinson et al. 1996), with transects set between 50 m and 150 m apart with the goal of describing the biophysical conditions of the Site. Six transects were established using marked lead lines and georeferenced positions for the start and end points of each transect. Divers used a high definition video camera and slates to record observations of all highly mobile fish and invertebrate species during the first pass along the transect line. During the return swim, a 1 X 1 m area was visually assessed in detail every 10 m for gauge depth, substrate type, percent cover of vegetation, and densities of invertebrates and fish. Survey data is summarized in **Table 1**, on **Figures 3 and 4**, plus in **Appendix A**. Established transects (T1-T6) are depicted on **Figure 3** and depth profiles for the transects are displayed on **Figure 4**.

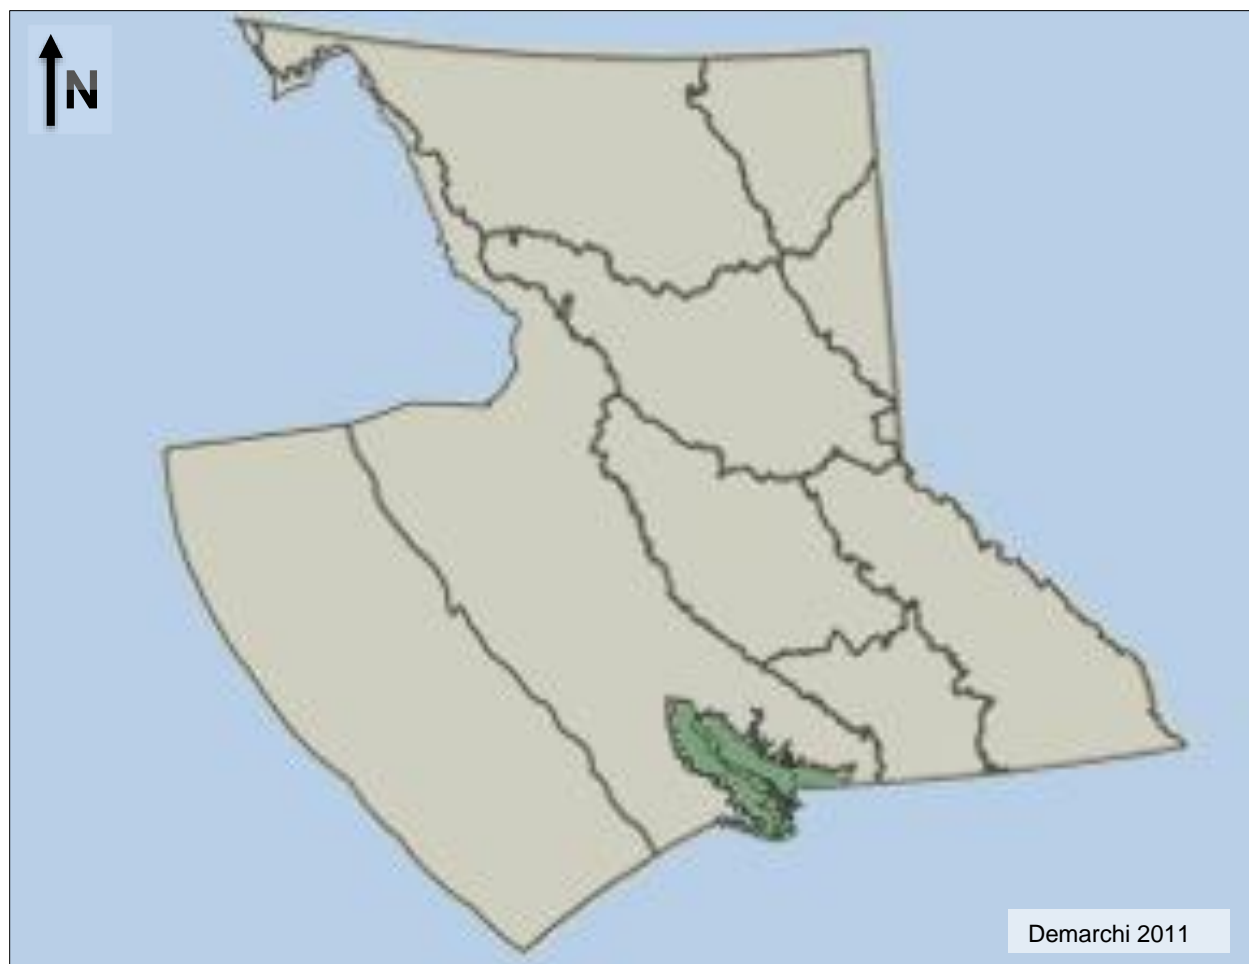
**Figure 5 Georgia Depression Ecoprovince**

The Project Site falls within the Georgia Depression Ecoprovince (**Figure 5**). Within the ecoprovince, the site overlaps with the Fraser Lowland Ecoregion component of the Lower Mainland Ecoregion and the Strait of Georgia Ecoregion within the Georgia-Puget Basin Ecoregion (Demarchi 1992). In the lowest portion of the Fraser Delta the dry Coastal Douglas-fir Zone occurs, inland the very dry maritime subzone of the Coastal Western Hemlock occurs, which gives way to the dry maritime subzone of the Coastal Western Hemlock zone on the highest areas. The marine environment is dominated by the Fraser River estuary, as well as intertidal and nearshore zones and an epipelagic zone that occurs within the Burrard Inlet.

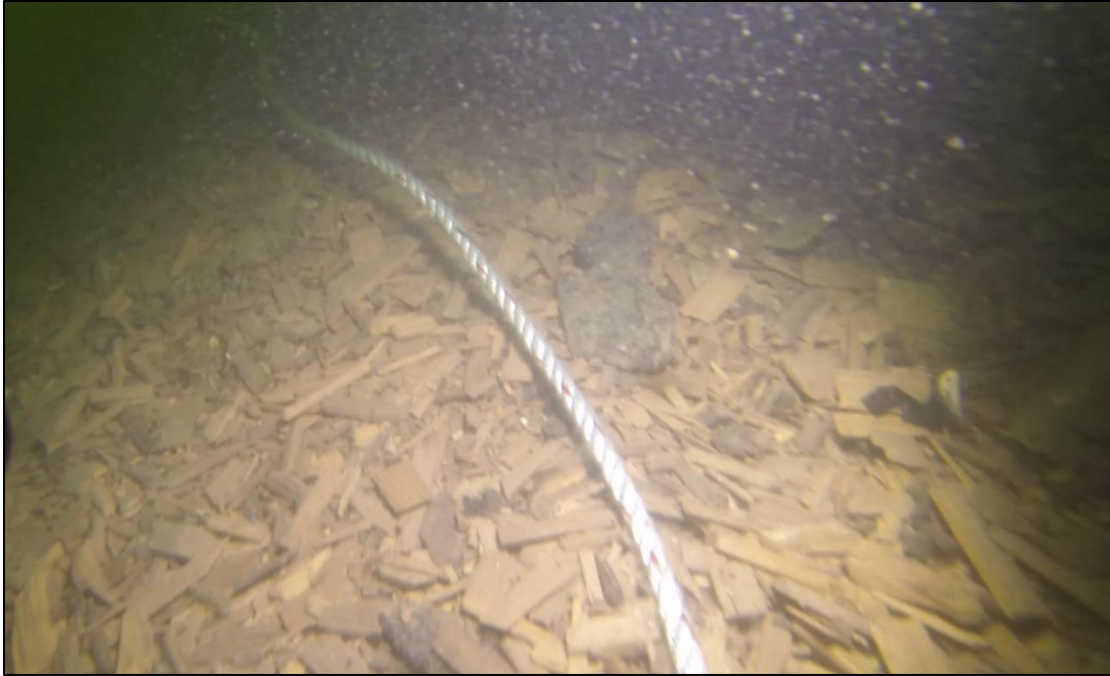
**Photo 3 Dense Wood Waste Observed Along Transect 2**

Wood waste was observed in isolated areas across the Site, but the majority of the intertidal and subtidal areas surveyed are free of wood waste. There was no accumulation of wood waste observed along transects T1 and T3, located in the central portion of the Site (**Figures 8 and 9**). This area, shoreward of the ship berth, had only minor fragments of wood waste with no areas of accumulation observed (**Photo 2, Appendix A**). South of the ship berth, along transects T2, T4, and T6, significant areas of wood waste accumulation were observed (**Photo 3, Appendix A**). The wood waste south of the ship berth was patchy and less consistent, narrowing in extent and observed mainly along the western transects (**Figure 9, Appendix A**). Accumulation in this area varied between large areas with 100% cover and > 30 cm depth, to areas with less than 100% cover of wood waste mixed with gravel and sand (**Photo 4**). Wood waste accumulation was most prevalent along the northern half of transect T5, where significant amounts of wood waste (100% cover, > 30 cm depth, **Photo 5**) were observed and bacterial mats covered some areas indicating hypoxic conditions.

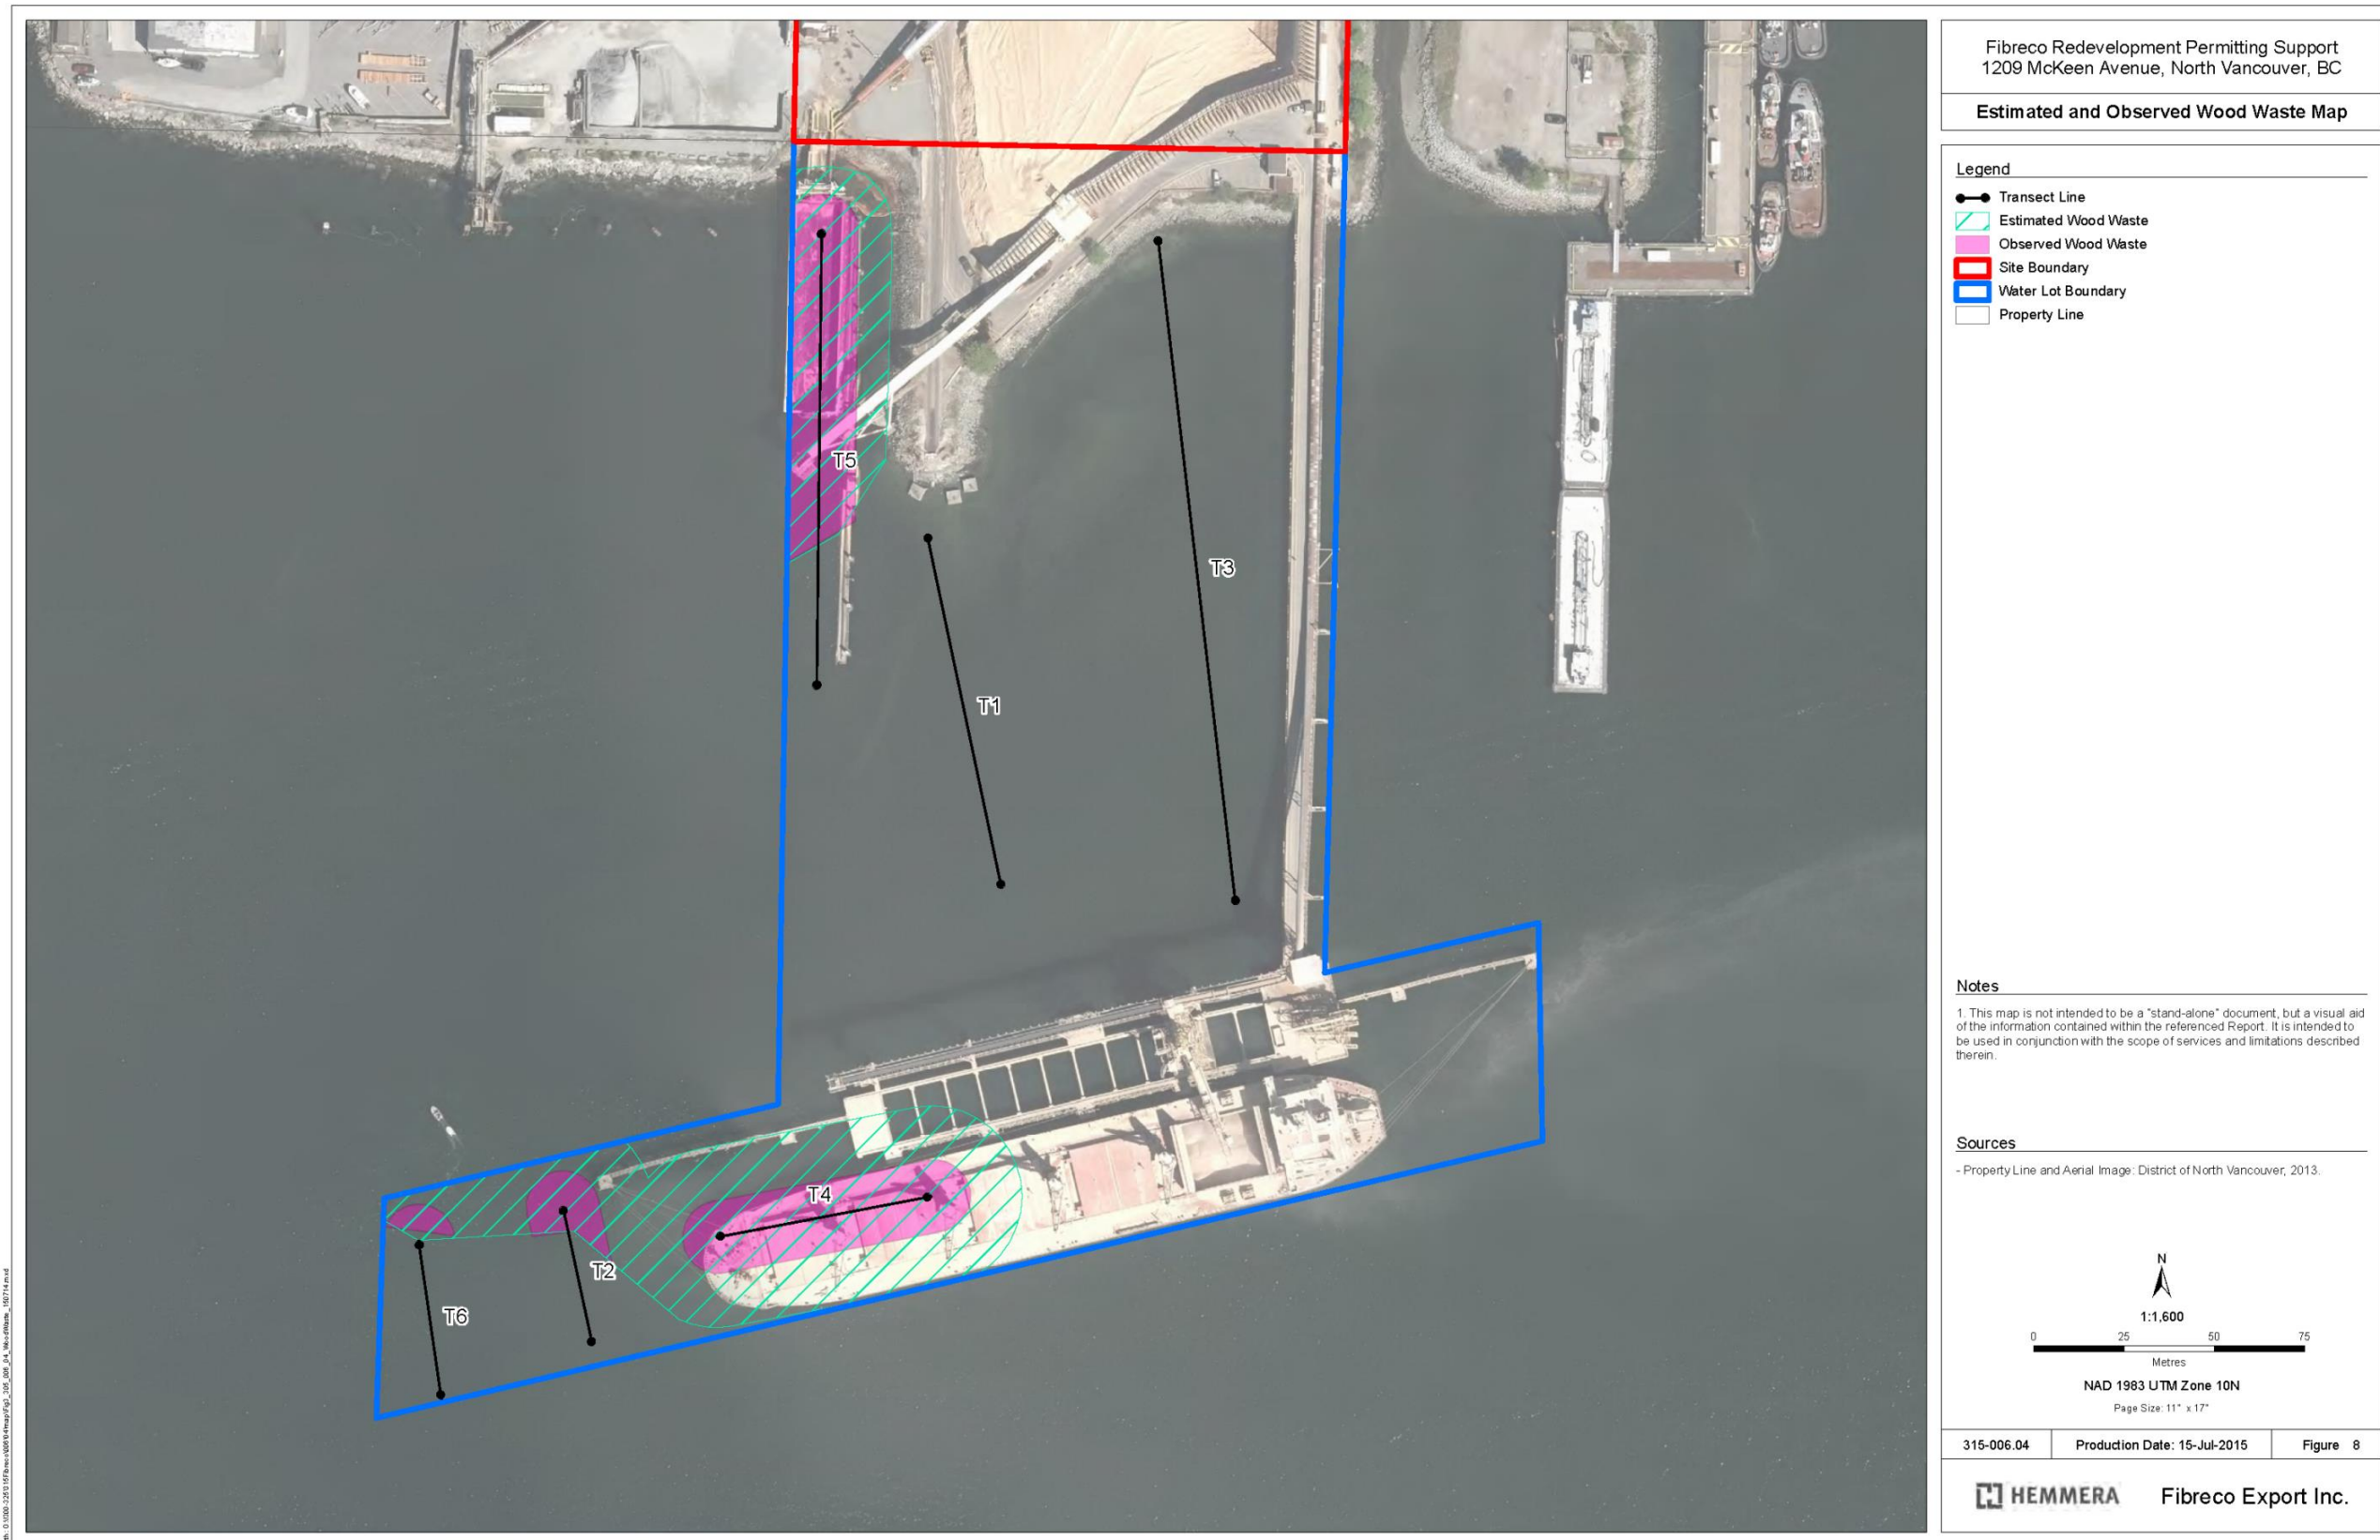
Figure 8 Observed and Predicted Wood Waste at the Site

Wood waste was observed south west of the ship berth and adjacent to the barge loading area. Areas where wood waste were observed had depths greater than 30 cm (limit of measure) and low habitat value. Estimates of total extent of wood waste around the ship berth area were not fully delineated during the two-day survey.

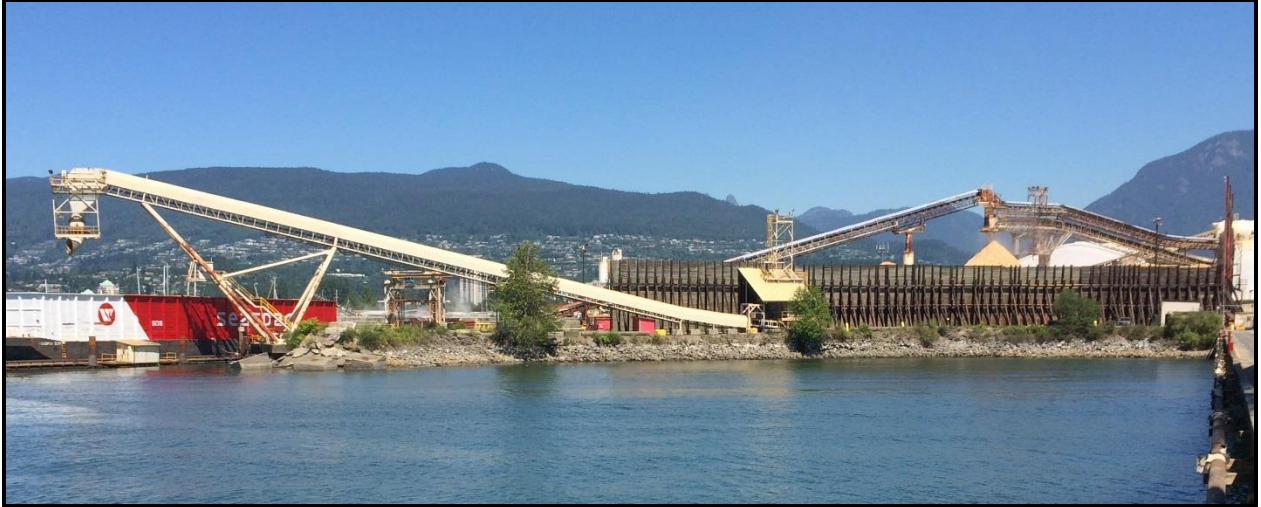
**Photo 6 Riparian Area Along Southern Side of the Site (looking north along causeway)**

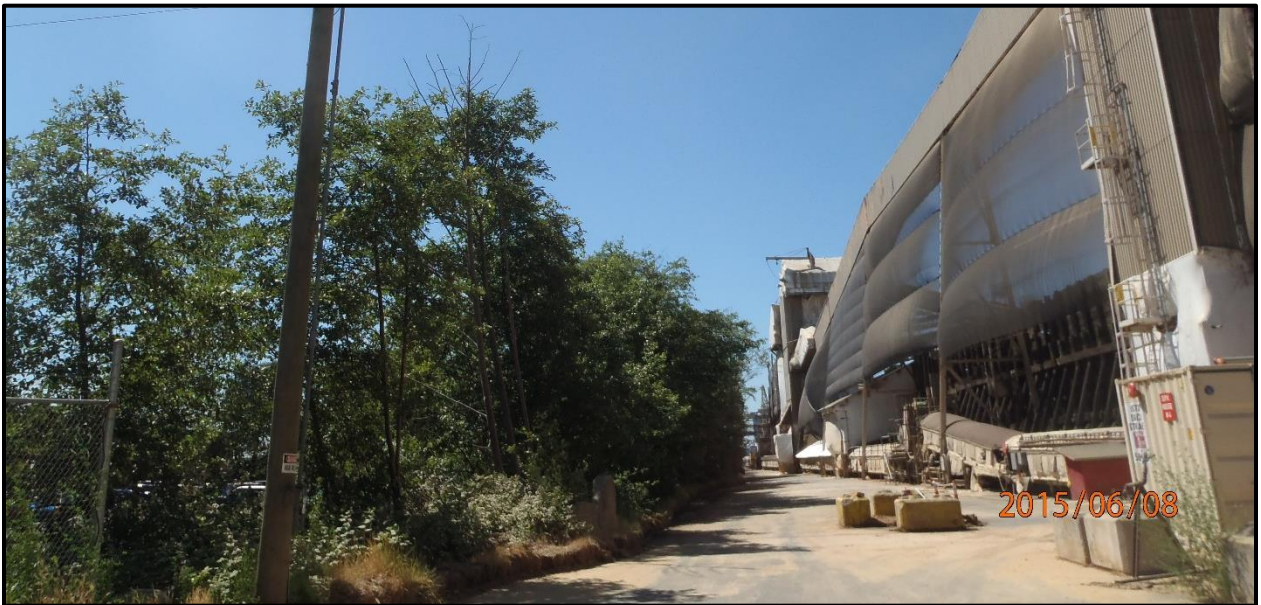
The Georgia Depression supports vegetation with the longest growing season in British Columbia. Vegetation is dominated by the Western Hemlock Zone (Demarchi 2011). A survey of the forested upland was not conducted as part of this assessment. However, the upland area is highly industrialized and only disturbance tolerant species, such as black cottonwood (*Populus balsamifera ssp. trichocarpa*) were observed at the foreshore (**Photo 6**). There is also a thin marine riparian area extending approximately 300 m in length and 6 m to 10 m in width, along the east side of the property with no coniferous species present (**Photo 7**).

**Photo 7 Riparian Area Along Eastern Side of the Site (looking south)**

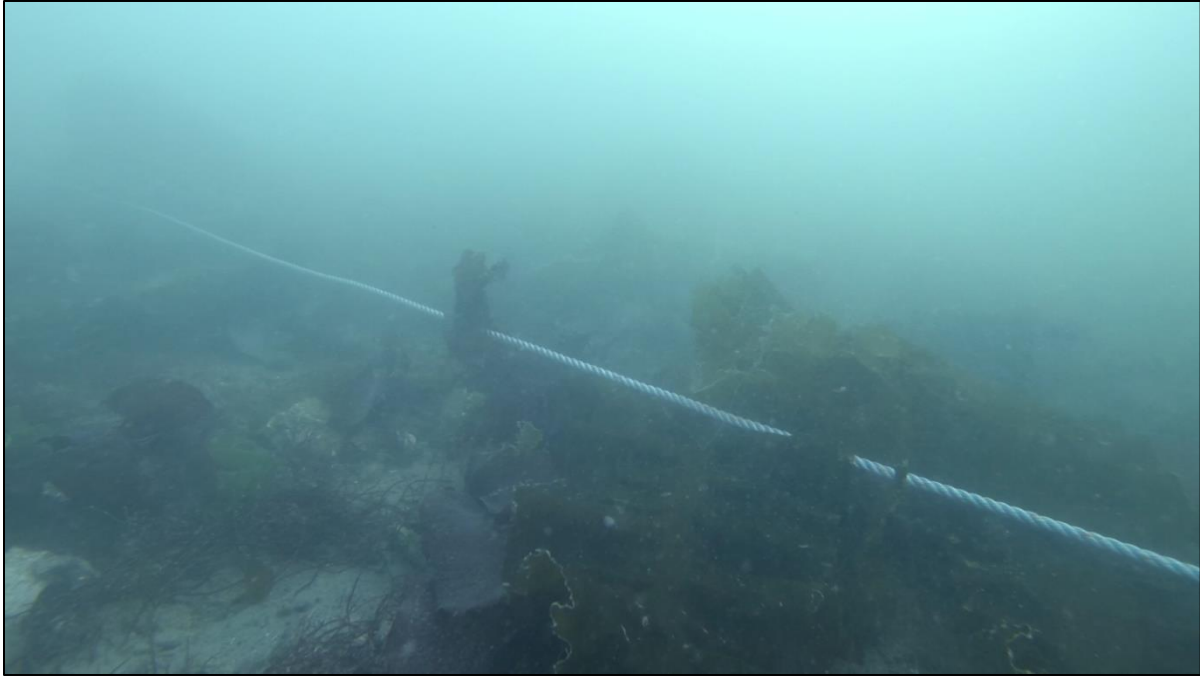
The subtidal marine assemblages observed within the Site are typical of hard substrates in Vancouver Harbour (Morris 2001, FREMP 2013, **Figure 11, Appendix A**). Brown macroalgae was distributed throughout the inside transects (T1, T3), which were characterized by a mix of brown kelp species including: bull kelp (*Nereocystis luetkeana*), five-rib kelp (*Costa costaria*), and sugar kelp (**Photo 8**), along with other common algal species including splendid iridescent seaweed (*Mazzaella splendens*), rockweed, sea lettuce, unknown red bladed and red filamentous species. The algal community observed along Transect T5 was similar to the inside transects, but only in areas without wood waste. The deep water transects (T2, T4, T6) were devoid of algae with a few small samples of red algae observed.

**Photo 8 Algal Community Along Inside Transect (T1)**

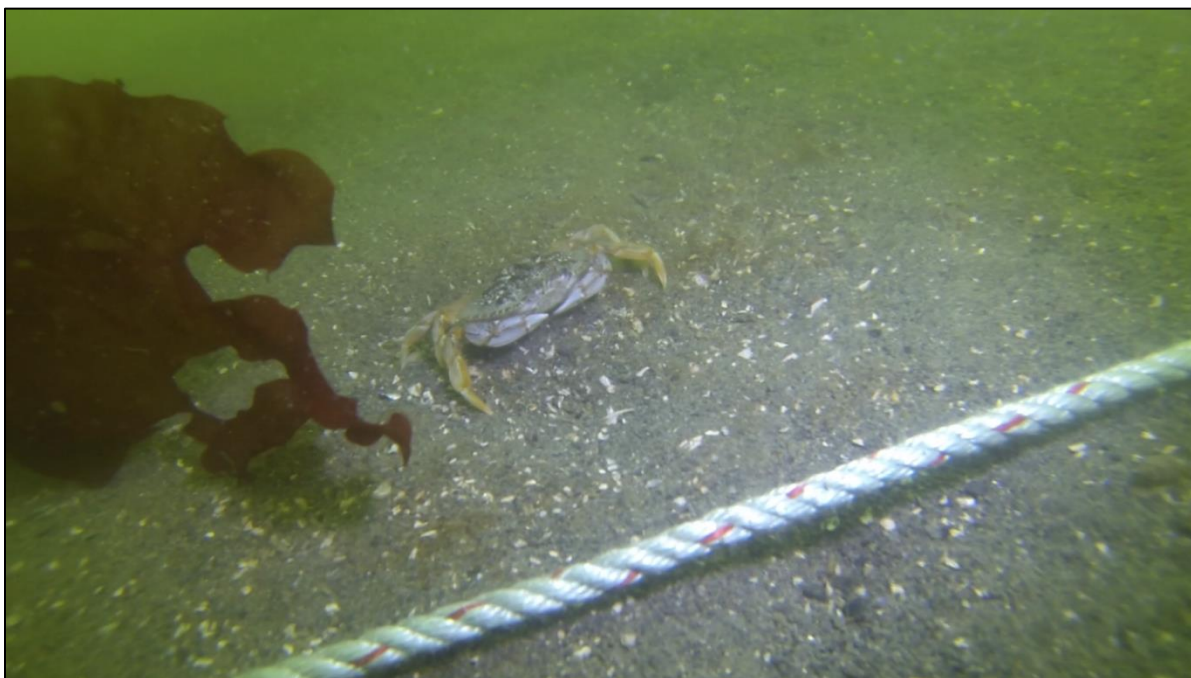
Invertebrate species observed during the subtidal transects included Dungeness crab (**Photo 10**), red rock crab (**Photo 11**), California sea cucumber (*Parastichopus californicus*), and intertidal bivalves (*Tresus spp.* and *Mya arenaria*). These species were abundant and commonly observed in the area between the ship berth and the south facing foreshore.

**Photo 10** Dungeness Crab on sandy substrate at observed along Transect 1, June 9, 2015.

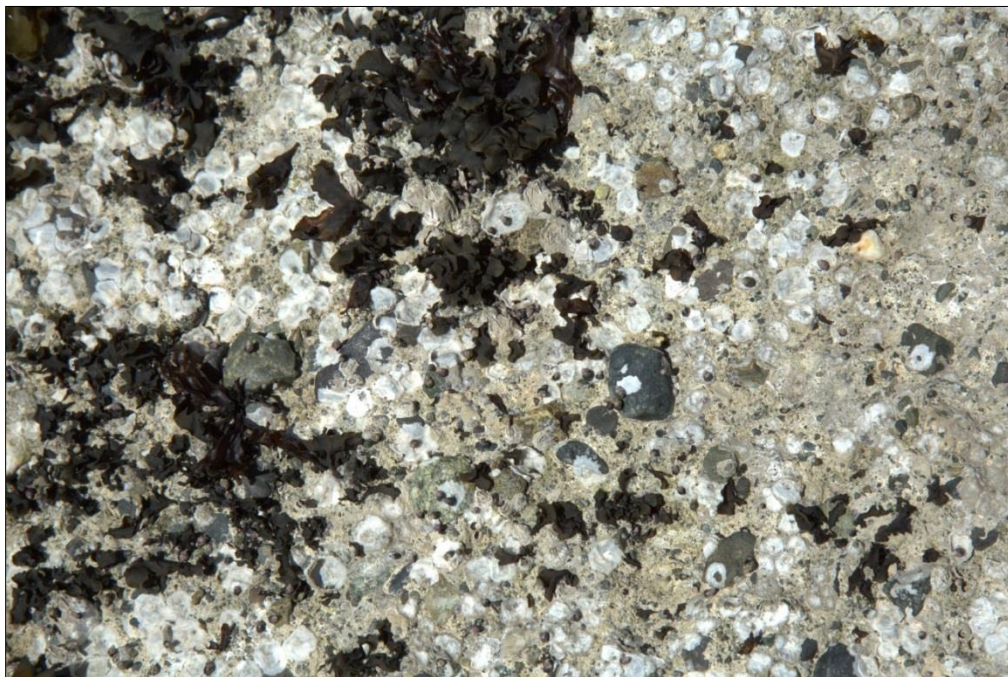
**Photo 4:** Turkish washcloth, acorn barnacles, and periwinkles on rip-rap of intertidal redevelopment area

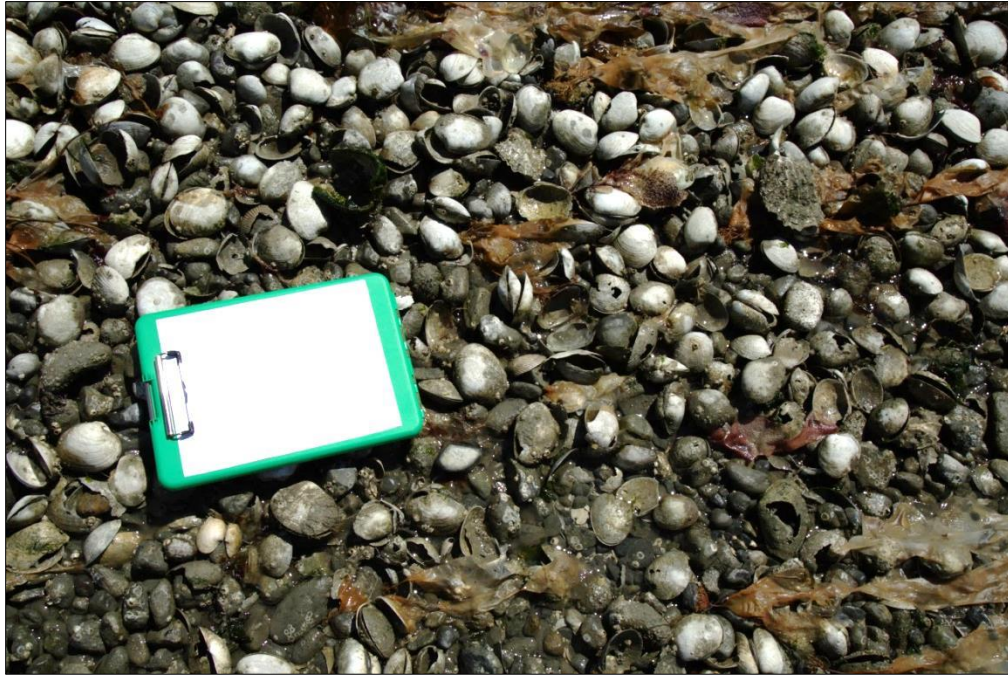
**Photo 5:** Bivalve shell debris in the foreshore adjacent to the redevelopment Site
