**STORMWATER MANAGEMENT PLAN FOR 1209 MCKEEN AVENUE
EXPANDED TO ADDRESS VFPA COMMENTS**

FINAL REPORT

Fibreco Export Inc.
North Vancouver, British Columbia

Northwest Hydraulic Consultants Ltd.
North Vancouver, British Columbia

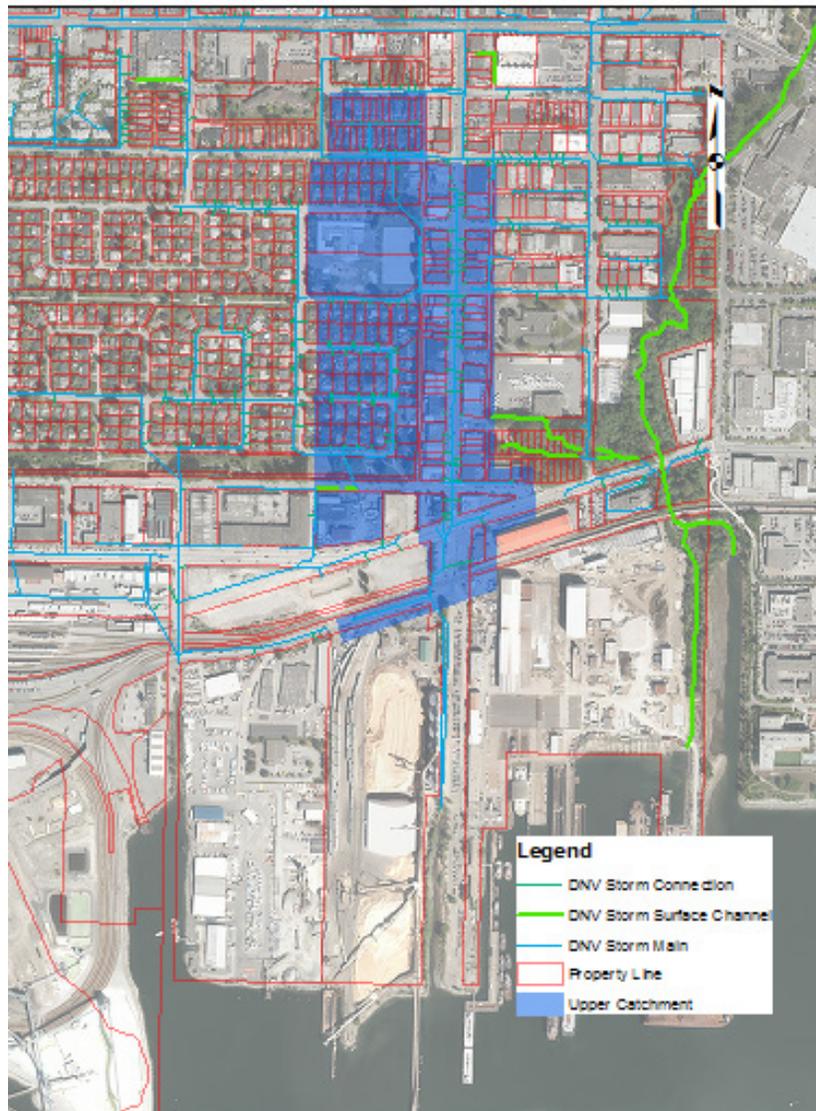
Figure 1. Catchment of DNV 1050 mm Trunk Storm Main Upstream of the Fibreco Site

In the northeast catchment, the drainage from the region occupies only a small percentage (<8%) of the 1050 mm DNV storm trunk. Upstream of the project site, the 1050 mm DNV storm trunk drains a

catchment area that is approximately 19 ha (blue shading in **Figure 1**). The upper catchment consists roughly 32% low density residential area, 36% mixed use commercial lots, and 32% roads and pavements. The composite runoff coefficient, R, for the upper catchment is 0.7 for events of 5 years to 10 years return period, and 0.75 for events over 100 years return period. The estimated runoff from the upper watershed during the 10-year event is 0.41 m³/s, and the runoff during the 100-year event is estimated to be 0.66 m³/s. Therefore, during the 100-year storm event, the total estimated discharge including from the Fibreco’s site to the 1050 mm storm trunk is 0.77 m³/s, under 60% of the capacity of the 1050 mm storm trunk.

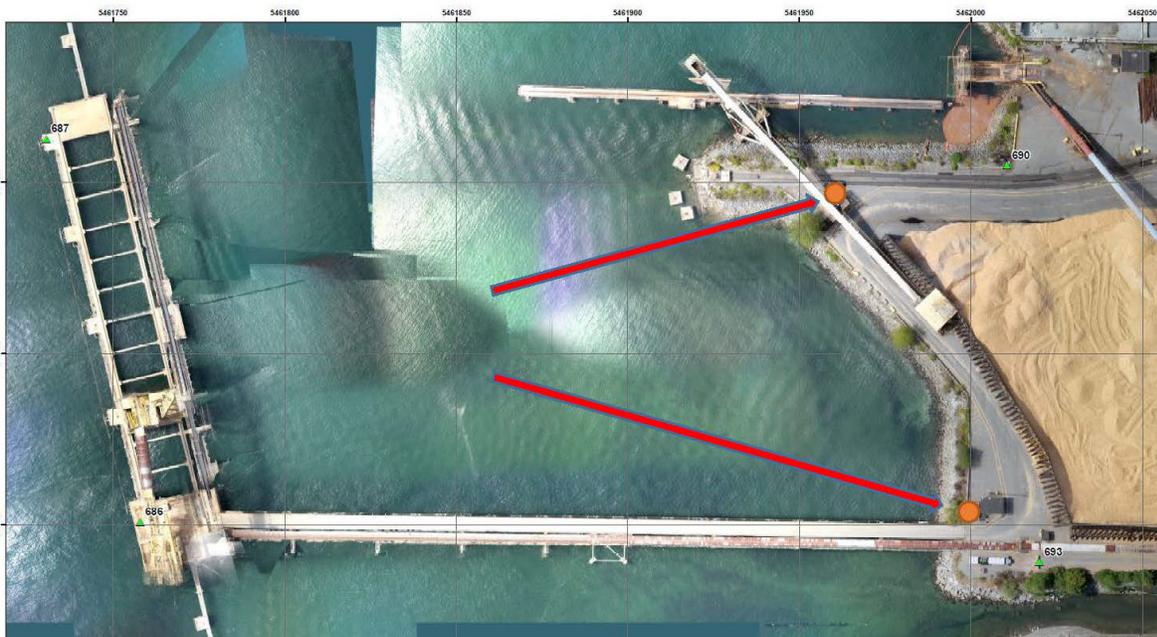
Figure 2. Discharge Points During Flushing of the Fire Pump Houses and Fire Lines

Fire pump houses and fire lines on site are inspected every four years. During the inspection, if sediments are observed in the fire lines or hoses, a flush will be carried out to clean the system and ensure the system is effective during fire emergencies. Discharge locations from such a flushing are shown in **Figure 2**.

At both locations water is discharged to the riprap armoured bank and is not expected to cause erosion or increase in sediment concentration in the receiving water. Portable water flushing through the fire distinguish system is considered safe to discharge by both Metro Vancouver and US Environmental Protection Agency (MV, 2007; USEPA, 2015).

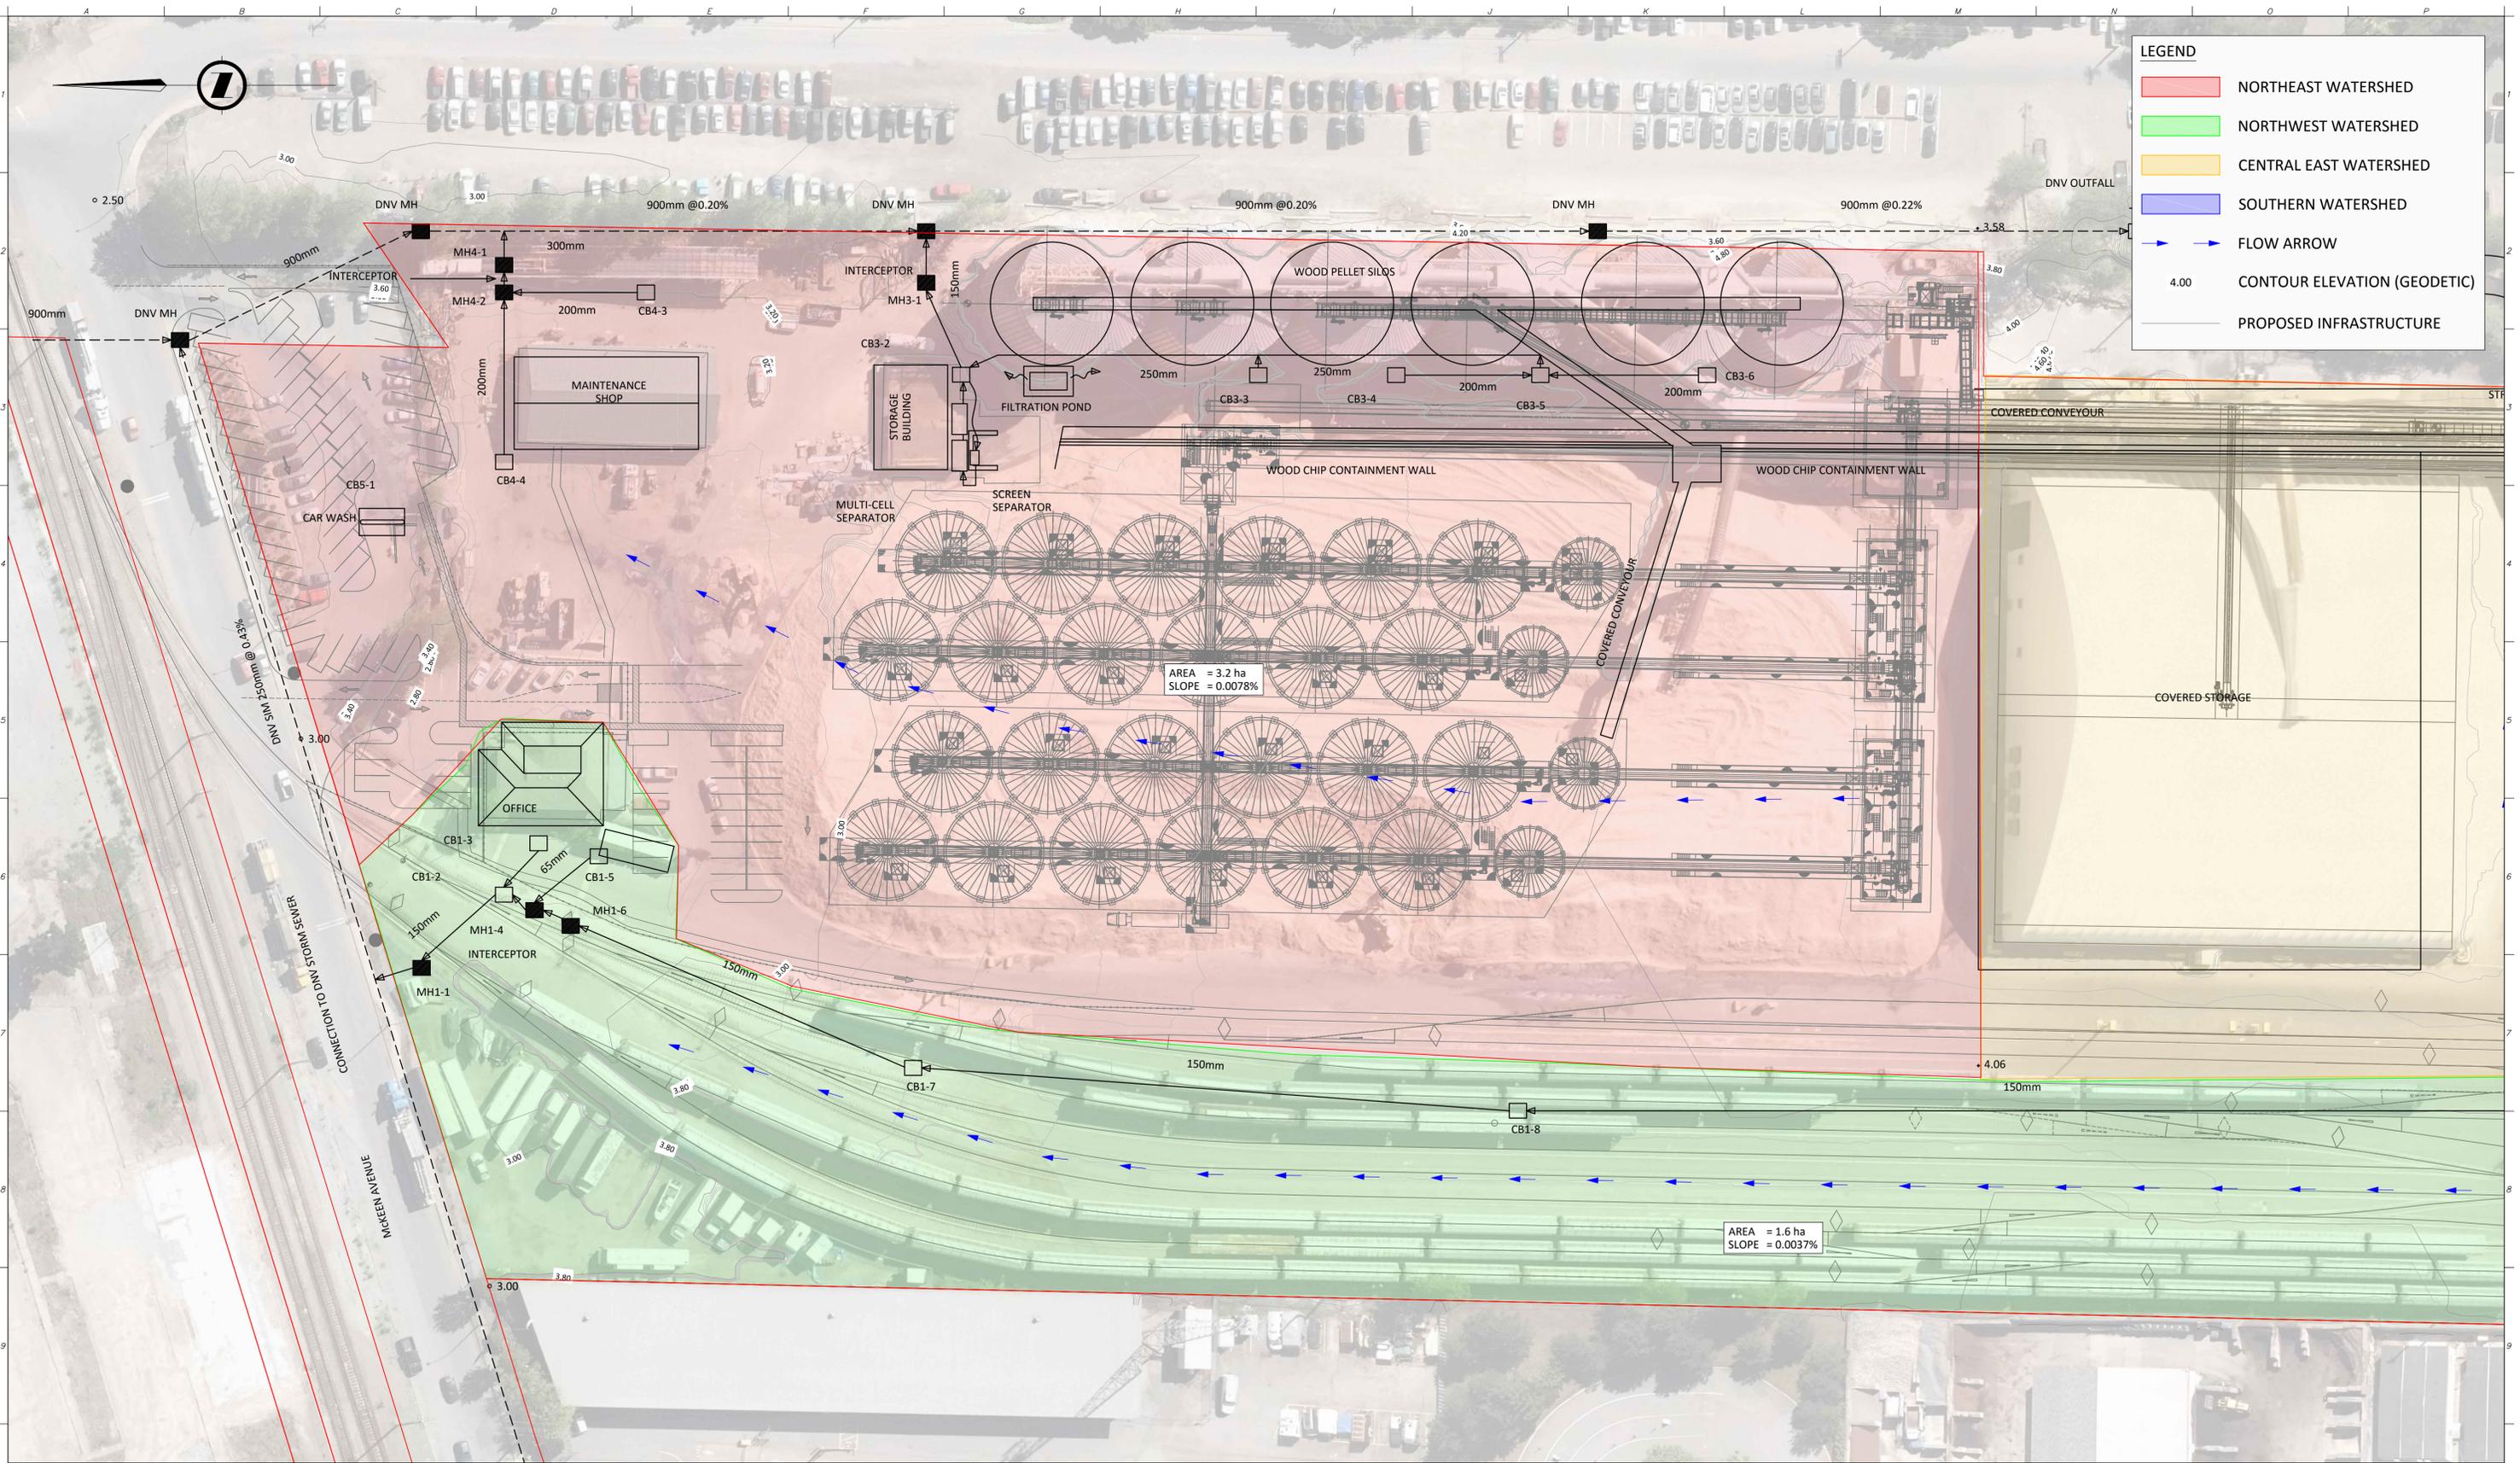
Drawing 1

- NORTHEAST WATERSHED
- NORTHWEST WATERSHED
- CENTRAL EAST WATERSHED
- SOUTHERN WATERSHED
- FLOW ARROW
- CONTOUR ELEVATION (GEODETIC)
- PROPOSED INFRASTRUCTURE
